# EXTERNAL FAÇADE REPORT

## HABITAT

## WOOLPACK LANE, NOTTINGHAM, NG1 1GJ

Report Number: CH/1370/27052020

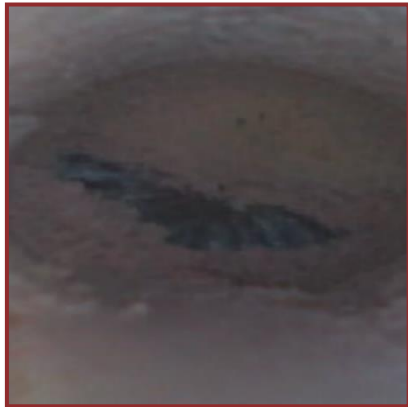
1C

- 7.1.2.2 The first of the three drill tests, at the highest point was found to be 100mm engineering brickwork which at approximately 45mm resisted and was found to come up against steel re-bar (*see photo 1C*).

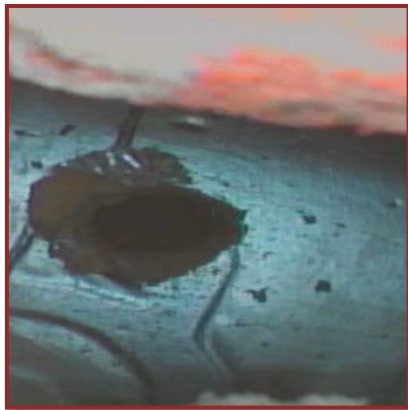
- 7.1.2.3 A second hole was drilled, in the approximate location of the floor slab, which was again found to be 100mm brickwork which was in front of a 80mm empty cavity onto 45mm foil backed phenolic rigid foam insulation ahead of the steel frame (*see photos 1D, 1E and 1F*).

7.1.3.4 As the cavity appears to not contain 75mm+ masonry to both leaves (as per Diagram 32), the exemption regarding the use of combustible insulation has not been satisfied.

7.1.3.5 Due to the absence of an internal masonry leaf, the evidence we have seen suggests that there have been material non-compliances with the advisory provisions of the ADB regarding the use of combustible thermal insulation, such that we do not think the building facade construction would comply with the mandatory clause within the Building Regulations, namely B4(1).

- 7.1.5.1 Due to the construction of the external wall in this area, prior to undertaking any wholesale remedial works, a further test to the external wall undertaken from internally would confirm the absence of a secondary masonry leaf prior to wholesale remediation works to the masonry areas. Following confirmation of our findings, the below recommendations will apply -

- 7.1.5.2 The two options which can be recommended regarding the potential remediation works in this location –
- a) The cavity of the internal wall should be encased with further 75mm+ masonry in this location to adhere to the requirements of provision within Diagram 32, or a fireproof structure/ construction.

- b) The combustible phenolic insulation should be removed from the cavity and replaced with an insulation material which achieves limited combustibility or better in accordance with the provisions of the ADB.

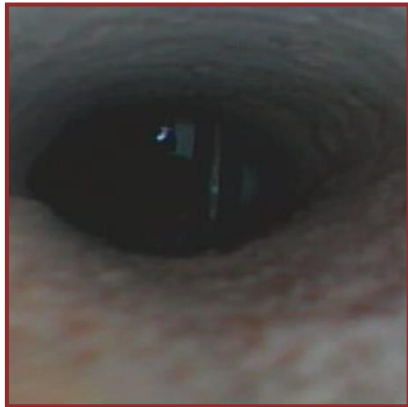
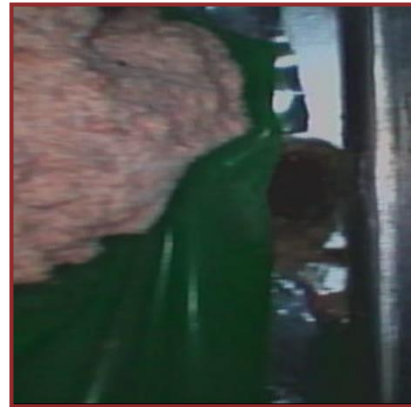
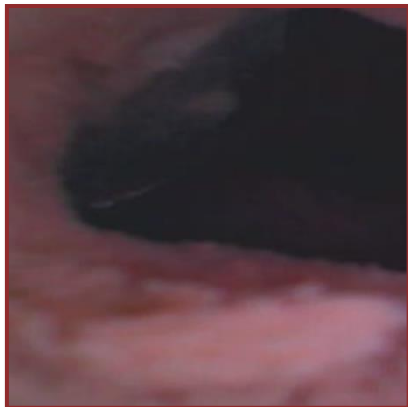
- 7.3.2.2 The construction was found to be 100mm engineering brickwork supported by an Ancon brick carrying system which was in front of a 80mm empty cavity to a combination of 25mm Kingspan phenolic rigid foam insulation and 95mm mineral wool insulation ahead of the internal plasterboard wall (*see photos 3C, 3D, 3E, 3F and 3G*).

7.3.5.1 Our recommendation within this area are consistent with Area 1, with an internal inspection recommended prior to wholesale remedial works.

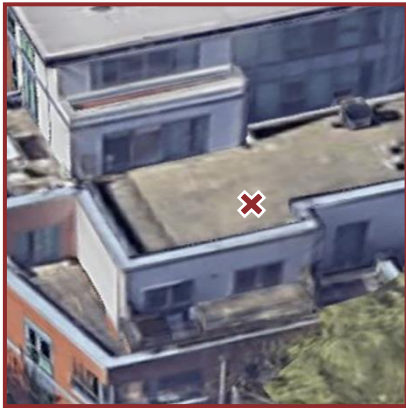
4A

7.4.2.1 Area 4 was a non-intrusive visual inspection carried out to the 7<sup>th</sup> floor roof terrace on the south facing elevation (*see photo 4A*).

7.4.5.1 It is our opinion that no further recommendations can be made to this area.

7.4.5.2 Human factor plays a large part in the cause of fire. Residents should be reminded of their responsibilities regarding reducing the risk of fire spread.

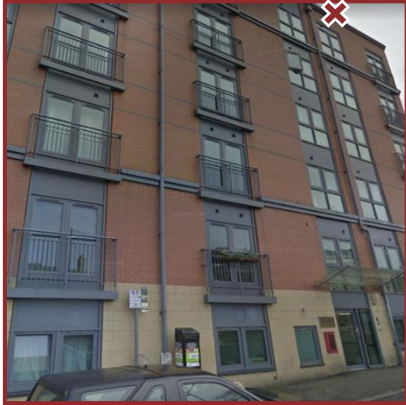
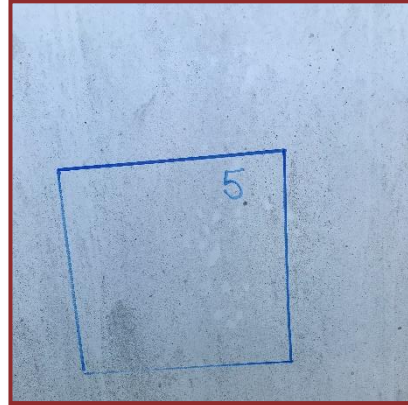
7.5.2.1 Area 5 was an intrusive inspection undertaken to the external rainscreen cladding on the seventh floor of the North facing elevation onto Woolpack Street. This had been relocated from its original location (*see photos 5A and 5B*).

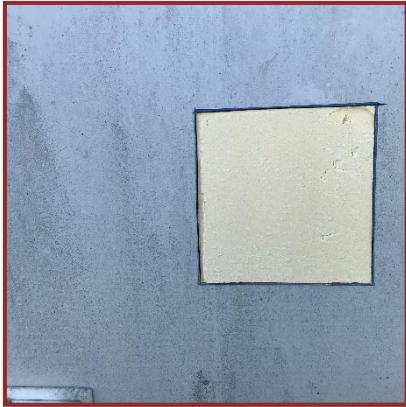
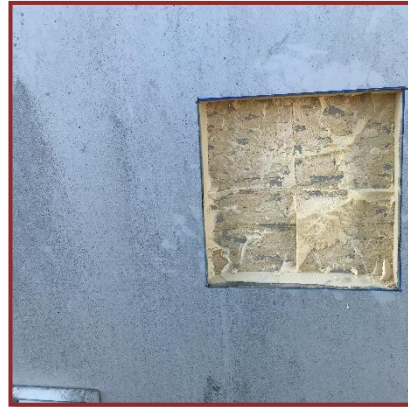
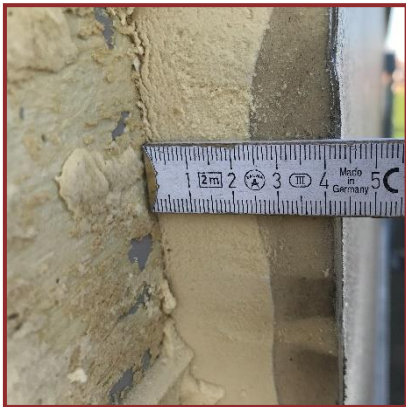
7.5.2.2 The cladding face was found to be a mild steel sandwich panel consisting of 1.5mm mild steel outer face, a 40mm rigid foam insulation inner core and a further layer of 1mm mild steel making up the internal face (*see photos 5C, 5D and 5E*).

7.5.3.7 Due to the presence of combustible insulation in this location, it is considered that there have been material non-compliances with the Approved Document, unless the system can demonstrate the successful completion of a BS8414-2 test, which, at the time of writing, we have not been made aware of. As such, it is

7.5.4.1 The presence of combustible insulation requires completion of a Holistic Fire Safety review, undertaken by a qualified Fire Engineer, with a view to confirming potential interim measures. The consideration of the risk offered by these materials will be considered in line with potential recommendations.

7.5.4.2 Due to the combustibility of the insulation within the construction, replacement of these material may be required.

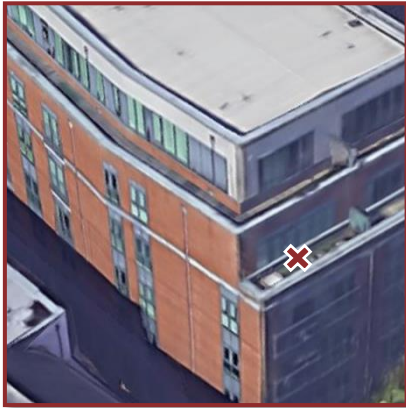
6A

7.6.2.1 Area 6 was a visual inspection carried out to the 6<sup>th</sup> floor roof terrace area to the South facing elevation to the western most wing (*see photo 6A*).

7.6.5.1 The terrace area is consistent with Area 4 in another part of the property, so no further inspection is required. The recommendations should be followed in accordance with those in other areas with the same construction.

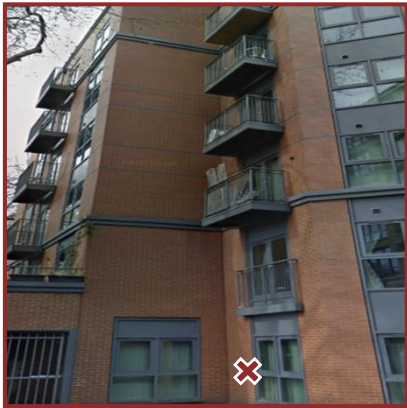
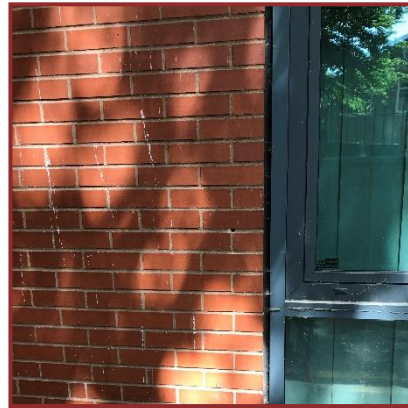
- 7.8.2.1 Area 8 was a drill test inspection carried out from the Ground floor roof of the South Elevation close to Area 7 *(see photos 8A and 8B)*
- 7.8.2.2 The construction was found to be a traditional 90mm brickwork which was in front of a 70mm empty cavity to a combination of 35mm foil faced phenolic rigid foam insulation, a slight cavity followed by and 105mm mineral wool insulation ahead of the internal plasterboard skin *(see photos 8C, 8D, 8E and 8F)*.
- 7.8.2.3 A secondary hole was drilled on the angle towards the window section to confirm how the cavity was closed to the opening. The window frame was visible with no other cavity closer *(see photo 8G)*.
- 7.8.2.4 Following the inspection, the mortar joint was sealed with waterproof mastic following the completion of works *(see photo 8F)*.

7.8.5.1 Our recommendation within this area are consistent with Areas 1 and 3, with an internal inspection recommended prior to wholesale remedial works.
