EXTERNAL FAÇADE REVIEW, HABITAT

Façade Remedial Consultants Ltd

JULY 23, 2020

Issue – Version 1.0

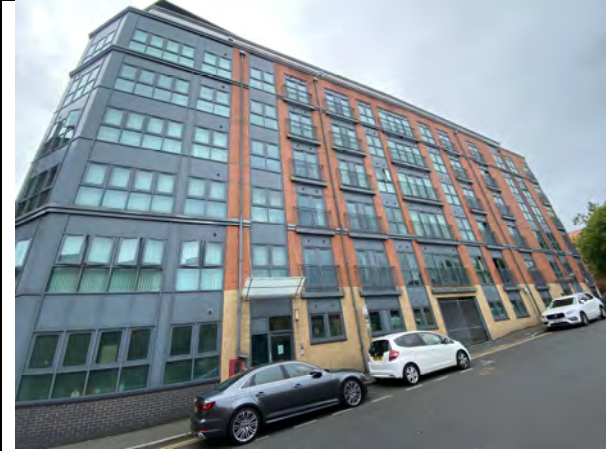
Our overall view is that the collective effect of the fire safety measures on the site considered holistically, as opposed to each measure in isolation, is that the external wall systems that are present have a detrimental impact on the overall fire safety of the building. The exterior of the development at this time does not comply with the consolidated guidance 'Advice for Building Owners of Multi-storey, Multi-occupied Residential Buildings' issued by Ministry of Housing, Communities and Local Government (MHCLG) in January 2020. This is due to the presence of combustible insulation found to the spandrel panels, and also timber decking to balconies which are vertically aligned.

Comment - We concur with the findings of the FRC report that the spandrel panels should be removed and replaced with a system achieving Euroclass A2 or better. The presence of a combustible core within the spandrel panels represents a risk of external fire spread and the extent of the panels is such that this may be widespread.

External façade to the front of the property, showing extensive spandrel panels

The spandrel panels should be removed and replaced with a system achieving Euroclass A2 or better. The presence of a combustible core within the spandrel panels represents a risk of external fire spread and the extent of the panels is such that this may be widespread.

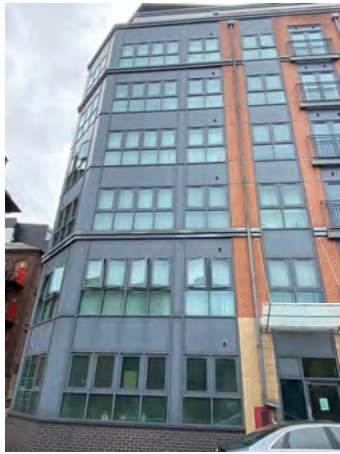
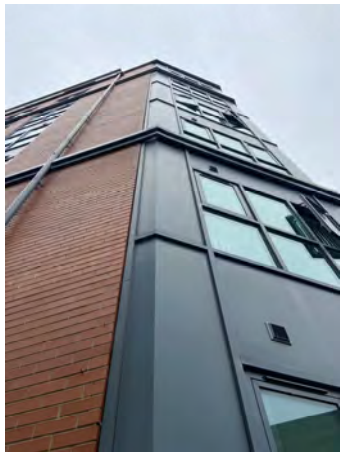
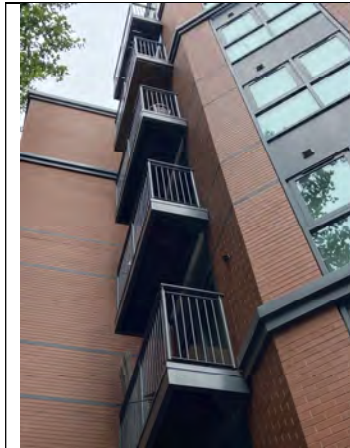
Comment - The balconies around the premises are vertically aligned and decked with a combustible timber decking. As such, this represents an opportunity for external fire spread, which is unacceptable. The timber decking should be replaced with materials achieving Euroclass A2 or better.

Balconies with exposed timber decking

The balconies around the premises are vertically aligned and decked with a combustible timber decking. As such, this represents an opportunity for external fire spread, which is unacceptable. The timber decking should be replaced with materials achieving Euroclass A2 or better.

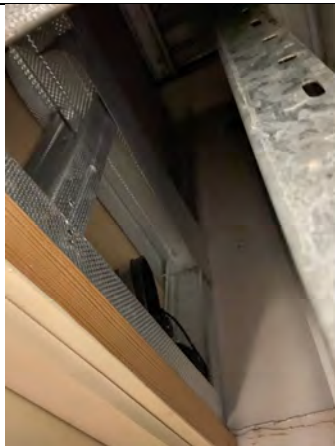
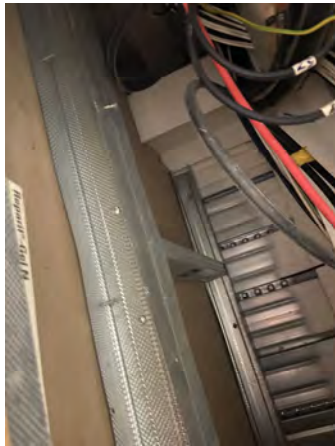
Inadequate fire stopping to riser cupboards

1. In a number of riser cupboards inadequate fire stopping was observed. We recommend a fire compartmentation survey is undertaken to identify all defects, and a remediation programme be implemented.
