# EXTERNAL FAÇADE REPORT

## HABITAT

## WOOLPACK LANE, NOTTINGHAM, NG1 1GJ

Report Number: CH/1370/27052020

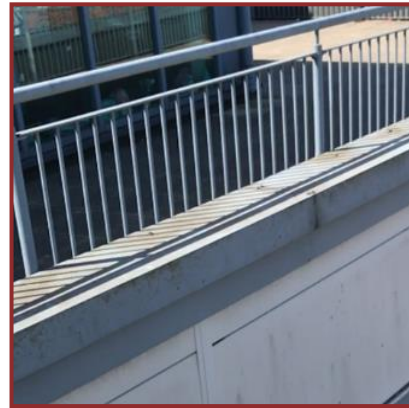
4B

7.4.2.3 The Balcony was constructed off the buildings steel frame, bolted back to the building structure with a steel handrail and steel balustrade (*see photo 4B*).

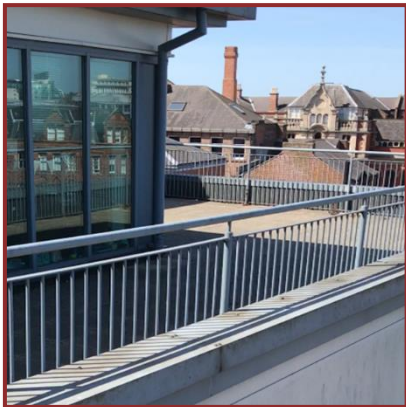
4C

7.4.2.4 The floor of the terrace was the main roof structure of the building which had been decked with concrete paving slabs (*see photo 4C*).

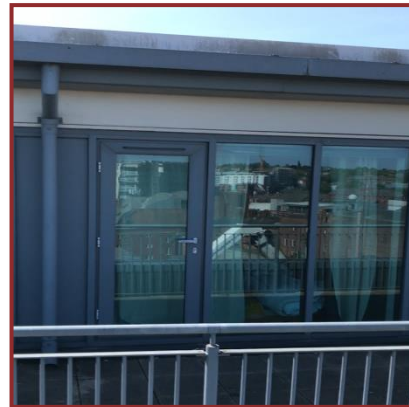
4D

7.4.2.5 The penthouse apartment was fronted with curtain glazing and rainscreen cladding (*see photo 4D*).

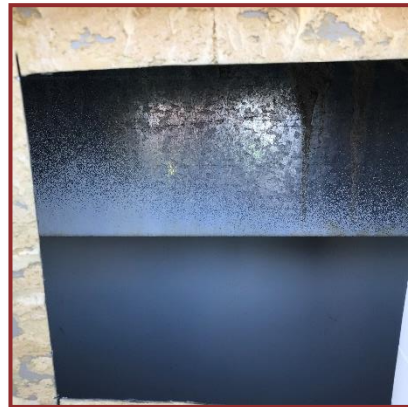
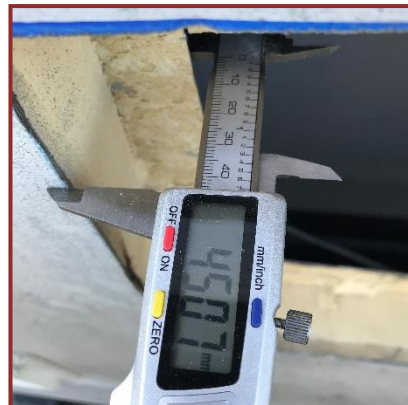
5F

7.5.2.3 Behind the panel was a large cavity between the face of the panel and the building's steel frame, measuring approximately 450mm (*see photos 5F& 5H*).

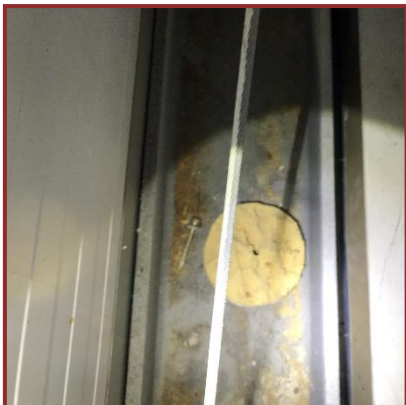
5G

7.5.2.4 Within the cavity, you can see the plasterboard internal skin to the apartment below with no apparent cavity barrier visible (*see photo 5G*).

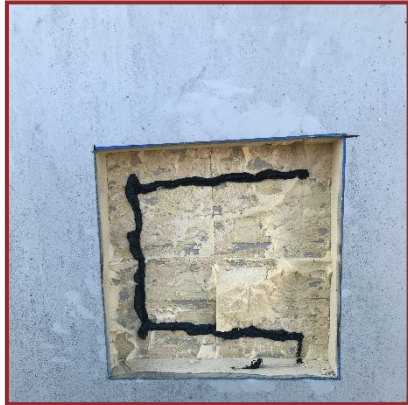
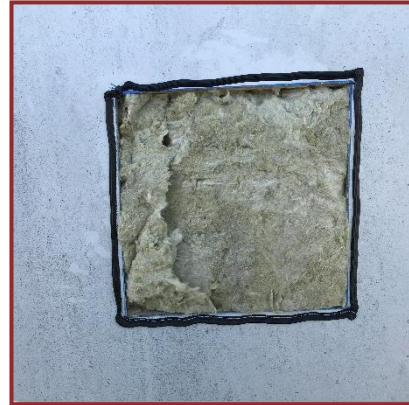
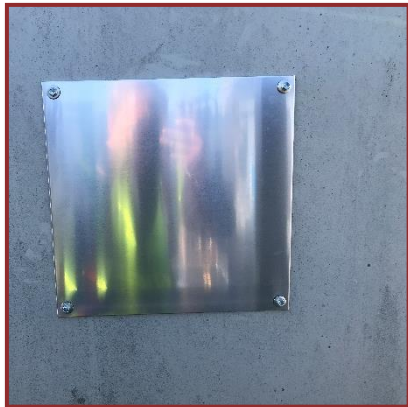
5I

7.5.2.5 Following completion of the inspection, the opening was filled with mineral wool insulation and sealed with waterproof mastic and a mechanically fixed, aluminium plate to prevent ingress (*see photos 5I, 5J and 5K*).

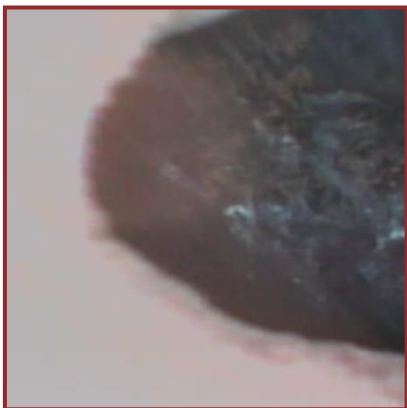
8G

- 7.8.2.1 Area 8 was a drill test inspection carried out from the Ground floor roof of the South Elevation close to Area 7 *(see photos 8A and 8B)*
- 7.8.2.2 The construction was found to be a traditional 90mm brickwork which was in front of a 70mm empty cavity to a combination of 35mm foil faced phenolic rigid foam insulation, a slight cavity followed by and 105mm mineral wool insulation ahead of the internal plasterboard skin *(see photos 8C, 8D, 8E and 8F)*.
- 7.8.2.3 A secondary hole was drilled on the angle towards the window section to confirm how the cavity was closed to the opening. The window frame was visible with no other cavity closer *(see photo 8G)*.
- 7.8.2.4 Following the inspection, the mortar joint was sealed with waterproof mastic following the completion of works *(see photo 8F)*.

7.8.5.1 Our recommendation within this area are consistent with Areas 1 and 3, with an internal inspection recommended prior to wholesale remedial works.

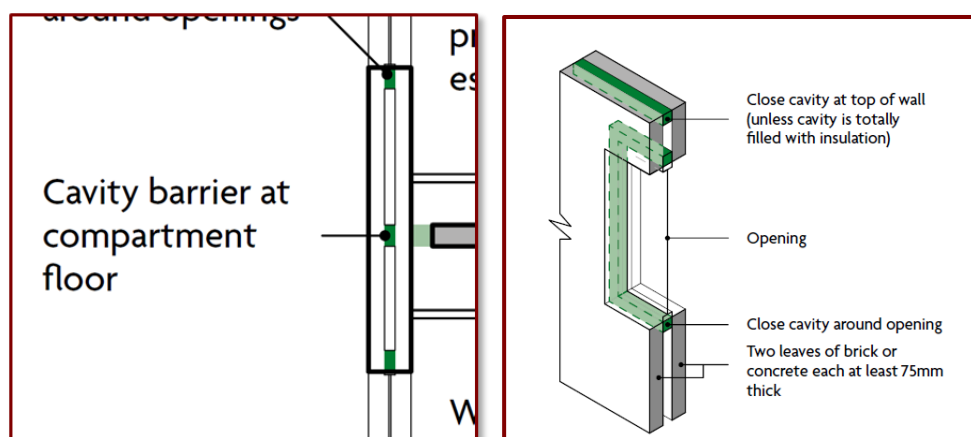
8.3.3 Section 9 of the Approved Document B2 2019 Provision of cavity barriers proves *"To reduce the potential for fire spread, cavity barriers should be provided for both of the following.*

- a. *To divide cavities.*
- b. *To close the edges of cavities."*
- c. With particular attention to cavity barriers around openings in external walls and at compartment floor slabs

8.3.2 We recommend that further to the advice from MHCLG the following items require attention:
